An Experiment in Preventing Zebra Mussel Settlement Using Electro-Expulsive Separation Technology

Nathan D. Mulherin and Andrew C. Miller

ERDC/CRREL SR-03-2
December 2003

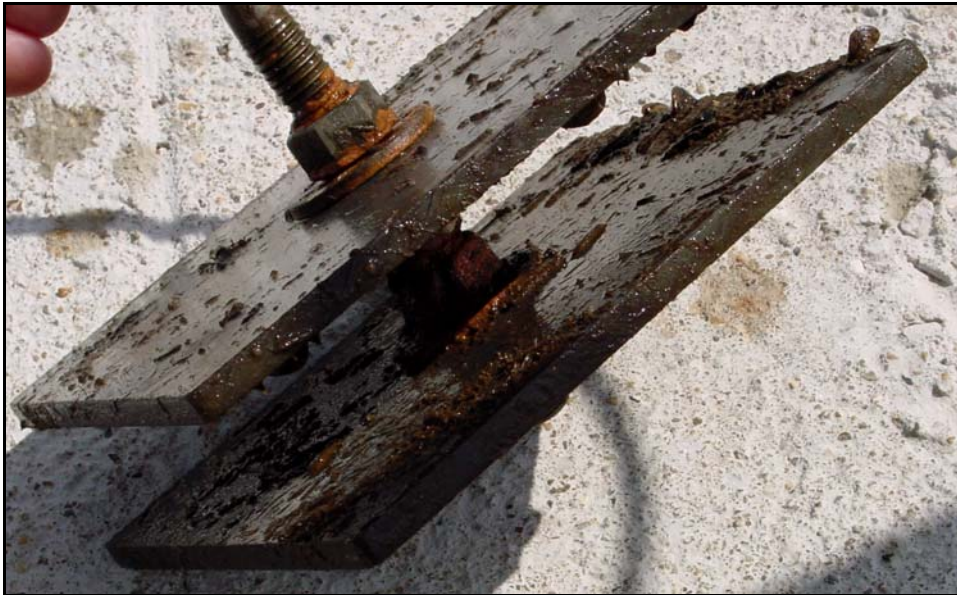
Figure 4 (cont'd). Plates used for mussel population sampling.

b. Set of small plates retrieved from the water, showing zebra mussels attached along the right-hand edge.

supports this hypothesis. It shows the mussels preferred attachment between the plates. This hypothesis is supported by research. USACE (2002), citing a study by Claudi and Mackie (1994), states that the juvenile stage of the mussel will settle on internal piping and submerged surfaces where the flow velocity is less than 1.5 m/sec. While the water velocity in the vicinity of our panels was not measured, local turbulence, as stated earlier, required us to weight the control panel to prevent it from swinging in the current. To better promote zebra mussel colonization of the test panels in a future experiment, consideration should be made for reducing the ambient current velocity in the vicinity of the test panels. This might be accomplished, for example, by placing the panels in a more sheltered location, or by enclosing them in baffled stilling boxes that will allow water to freely circulate but at much lower velocity. We anticipate that, with implementation of these changes in our experimental equipment and protocol, and funding for another field season to collect data, our zebra mussel control concept can be proven.

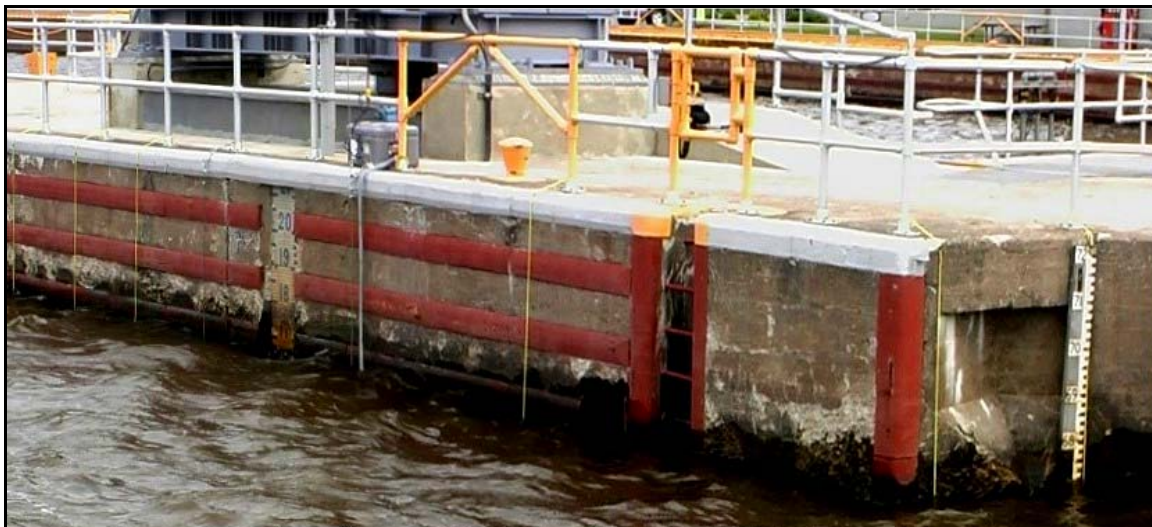
Figure 5. Experimental arrangement at Lock and Dam 4, showing relative positions of field components.

To quantitatively document the mussel population at Lock 4, additional strings of PVC sampler plates were suspended in the water adjacent to the panels. It was hoped that the sampler plates would colonize with zebra mussels and provide background information on density and size demography of natural populations in the vicinity of the experiment. The samplers were constructed of two 0.25-in.-thick (7-mm) PVC plates measuring 6 in. (15 cm) on a side with a 0.6-in.- (15-mm-) diameter hole in the center of each. Two plates were positioned horizontally 2.4 in. (7 cm) apart on an eyebolt, and held in place with nuts and washers (Fig. 4). A rope was secured to the eyebolt with the other end attached to a metal railing post at the top of the lock wall. Plate samplers were centered approximately 4.5 ft (1.4 m) beneath the water surface for the summer. The field components were arranged on site as shown in Figure 5.

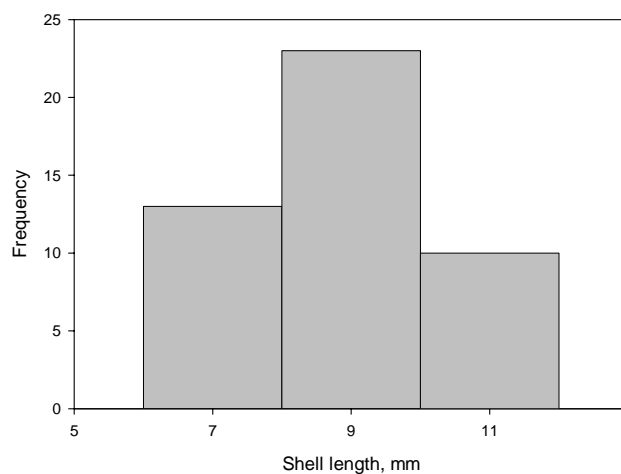
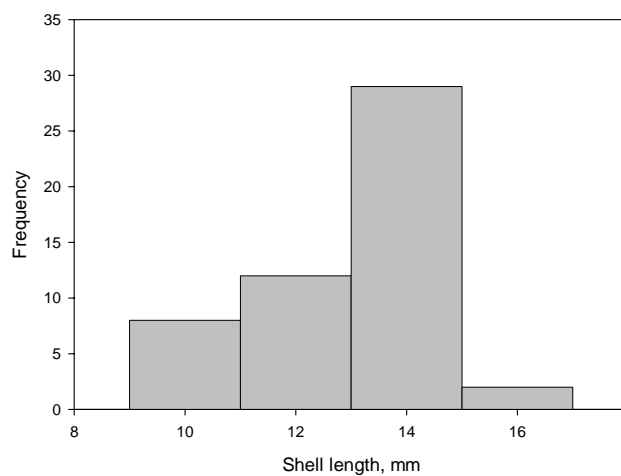
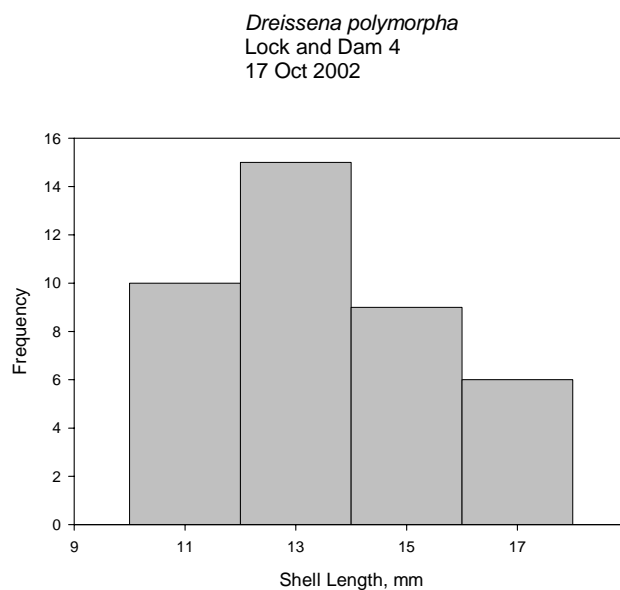
Figure 7. Length frequency histograms for zebra mussels collected from sampler plates at Lock 4.

Length frequency histograms for zebra mussels in August, September, and October 2002 appear in Figures 7a–c, respectively. In August, the majority of the mussels were 9 mm long and none were longer than 11 mm. In September 2002 the majority were 14 mm long and the maximum size was 16 mm. Between 5 July and 9 August (35 days), zebra mussels grew an average of 11.72 mm (and possibly more, since they could have settled after 5 July). Between August and September and between September and October, zebra mussels grew an average of 4.33 and 0.55 mm, respectively. See Table 3 for estimated growth rates of the zebra mussels on plate samplers at Lock and Dam 4 during the 2002 season.

a. August 2002.

b. September 2002.

c. October 2002.
